The NRC and Nuclear Power Plant Safety in 2014

Tarnished Gold Standard

David Lochbaum

March 2015

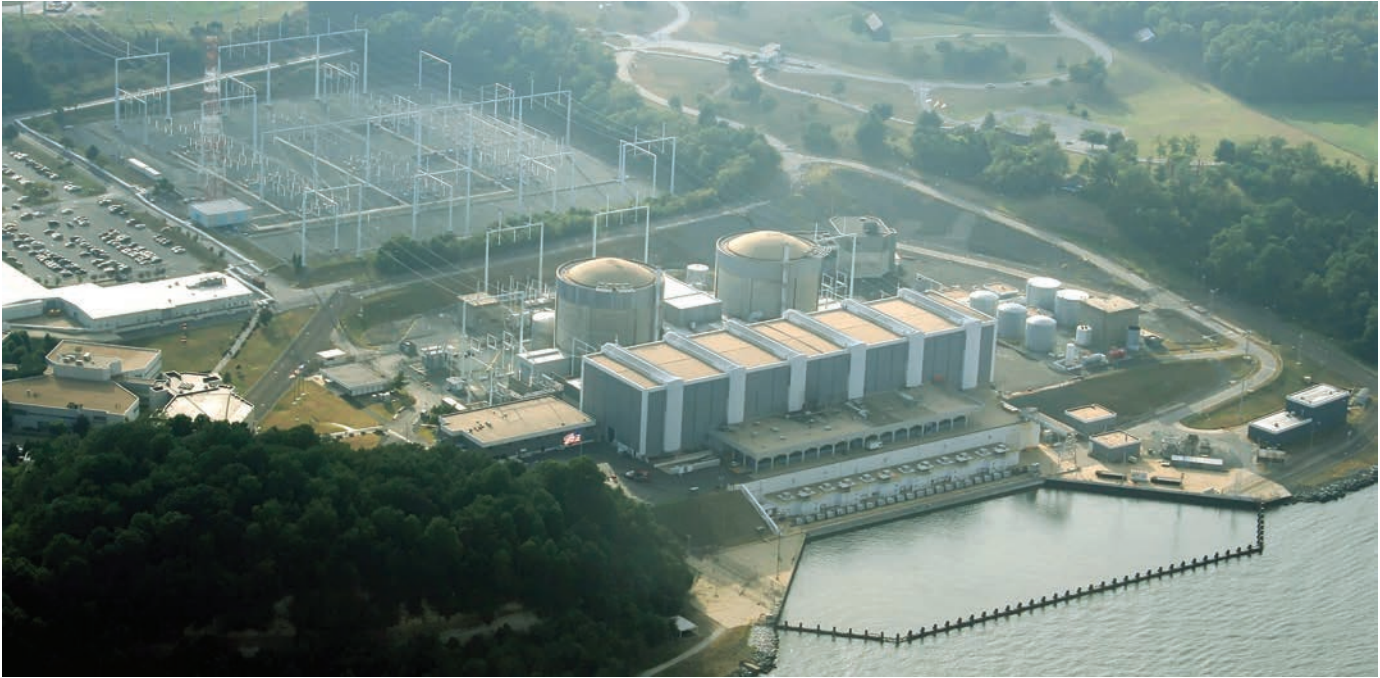
The Calvert Cliffs Nuclear Power Plant, where water leaked in during a winter storm to short out electrical circuits and force both reactors to automatically shut down.

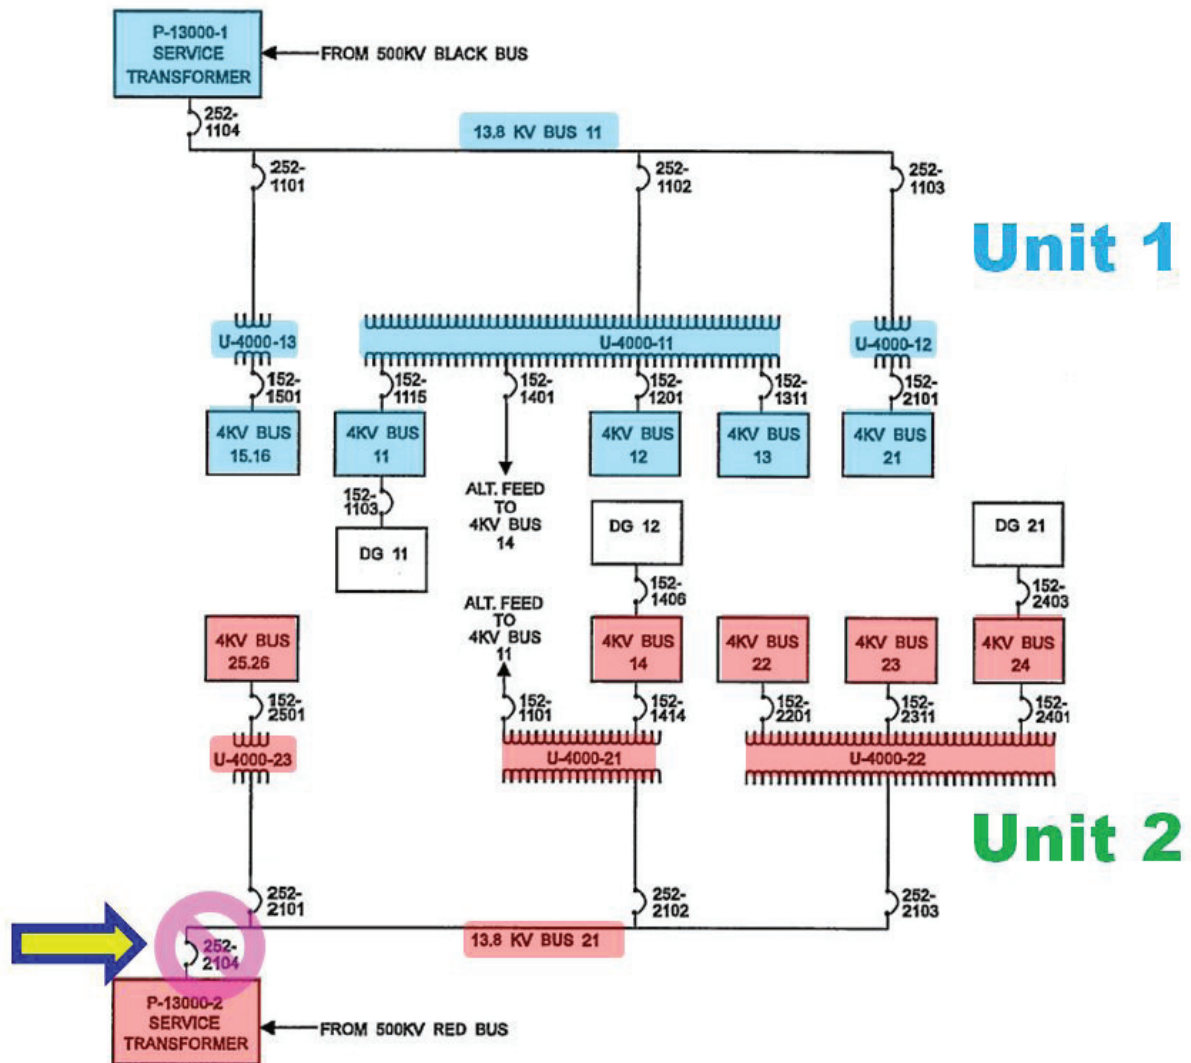
FIGURE 2. Initial Fault on the Electrical Distribution System at Calvert Cliffs

At approximately 9:25 p.m. on January 21, 2014, an electrical breaker shorted out due to water leaking in during a winter storm. The faulted breaker stopped the flow of electricity to the 13,800-volt (13.8 KV) electrical bus 21 on Unit 2. The de-energizing of bus 21 caused 4,000-volt (4KV) buses 14, 22, 23, 24, 25 and 26 to also de-energize (Figure 2, p. 10).

Problems began at Calvert Cliffs when water leakage during a winter storm shorted an electrical breaker that interrupted the supply of electricity to plant equipment.

Bus 21 was repowered on January 25 after repairs to the electrical breaker.

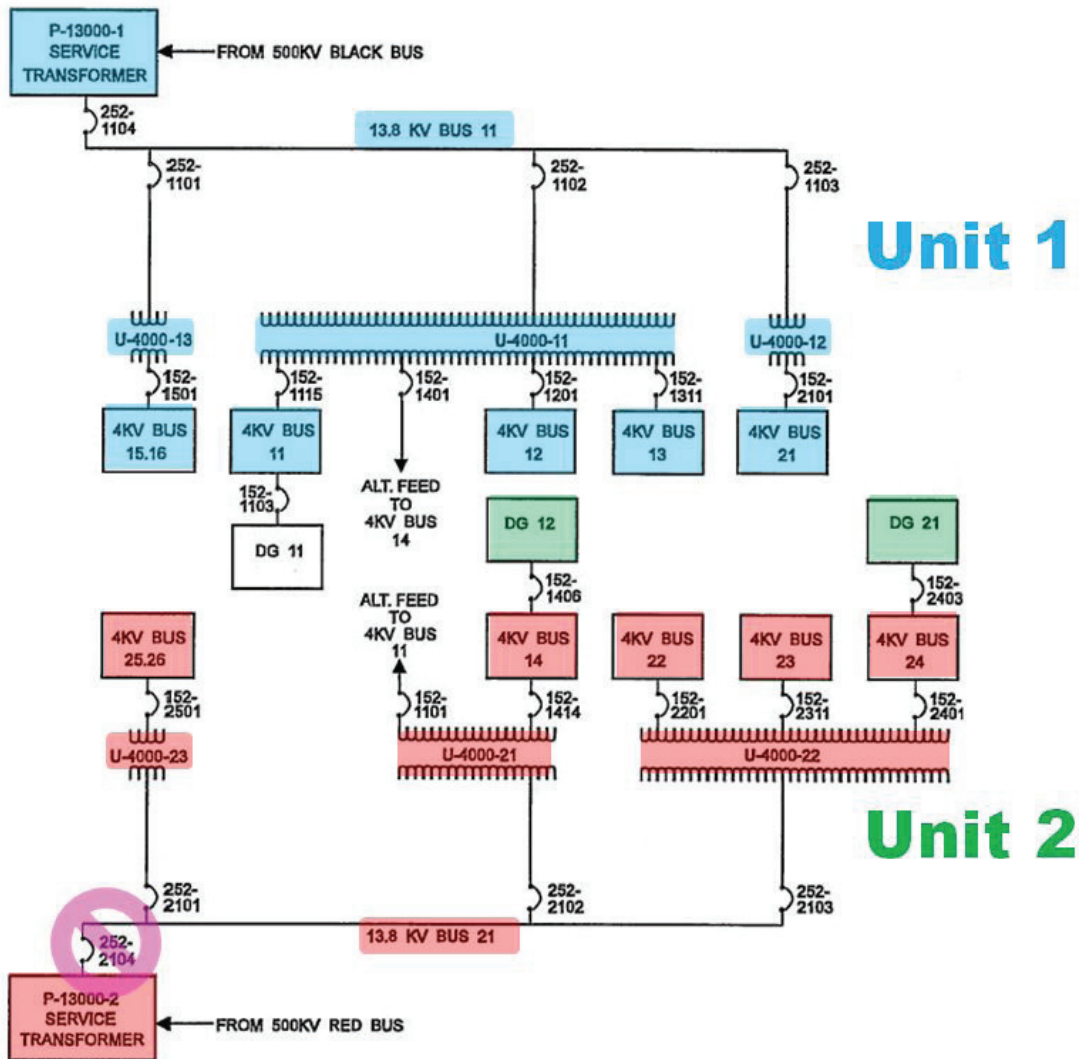
FIGURE 3. Response to Fault on the Electrical Distribution System at Calvert Cliffs

Emergency diesel generators automatically started and restored power to key electrical circuits, but the momentary power interruption caused Unit 2's problems to also cause problems on Unit 1.

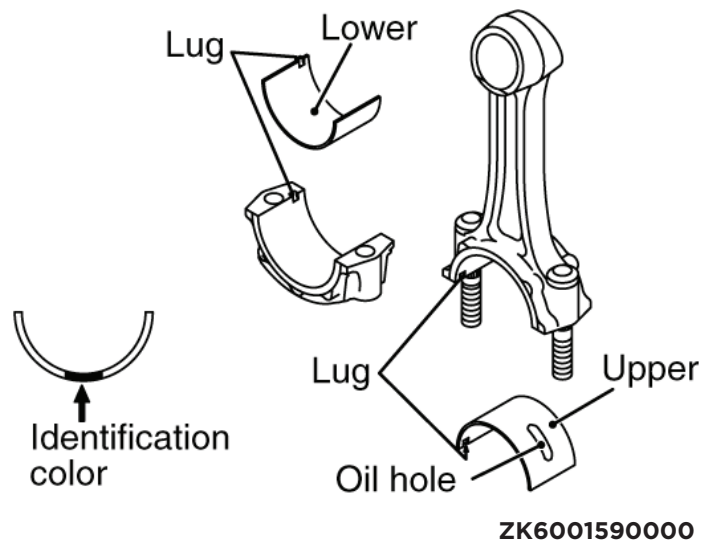
FIGURE 5. Half-Shell Bearings

Misalignment of the bearings could cause the emergency diesel generator to fail. The inner surfaces of the bearings have special coatings to allow them to better accommodate the rotating crankshaft. Lubricating oil also flows into the area for further protection against metal-to-metal rubbing. Misaligned bearings could block the inlet port for the lubricating oil, however, making it only a matter of time before the crankshaft and connecting rods lock together and damage the diesel engine.

A hole in the lower half-shell bearing allows oil to enter and lubricate where the metal connecting rod contacts the metal bearings.

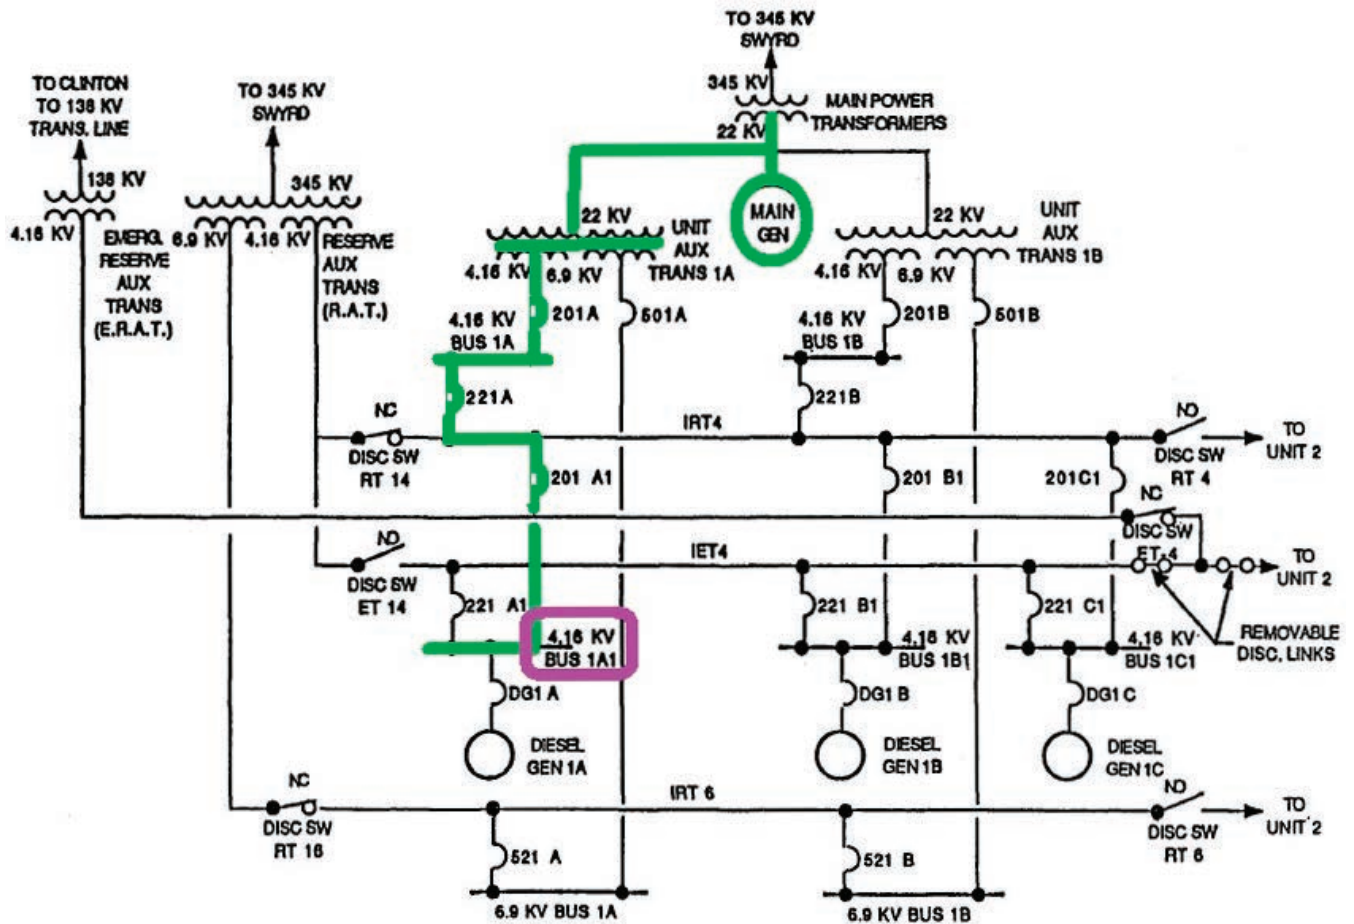
FIGURE 6. Electrical Distribution System at Clinton

An electrical problem interrupted the normal supply of electricity to plant equipment at Clinton.

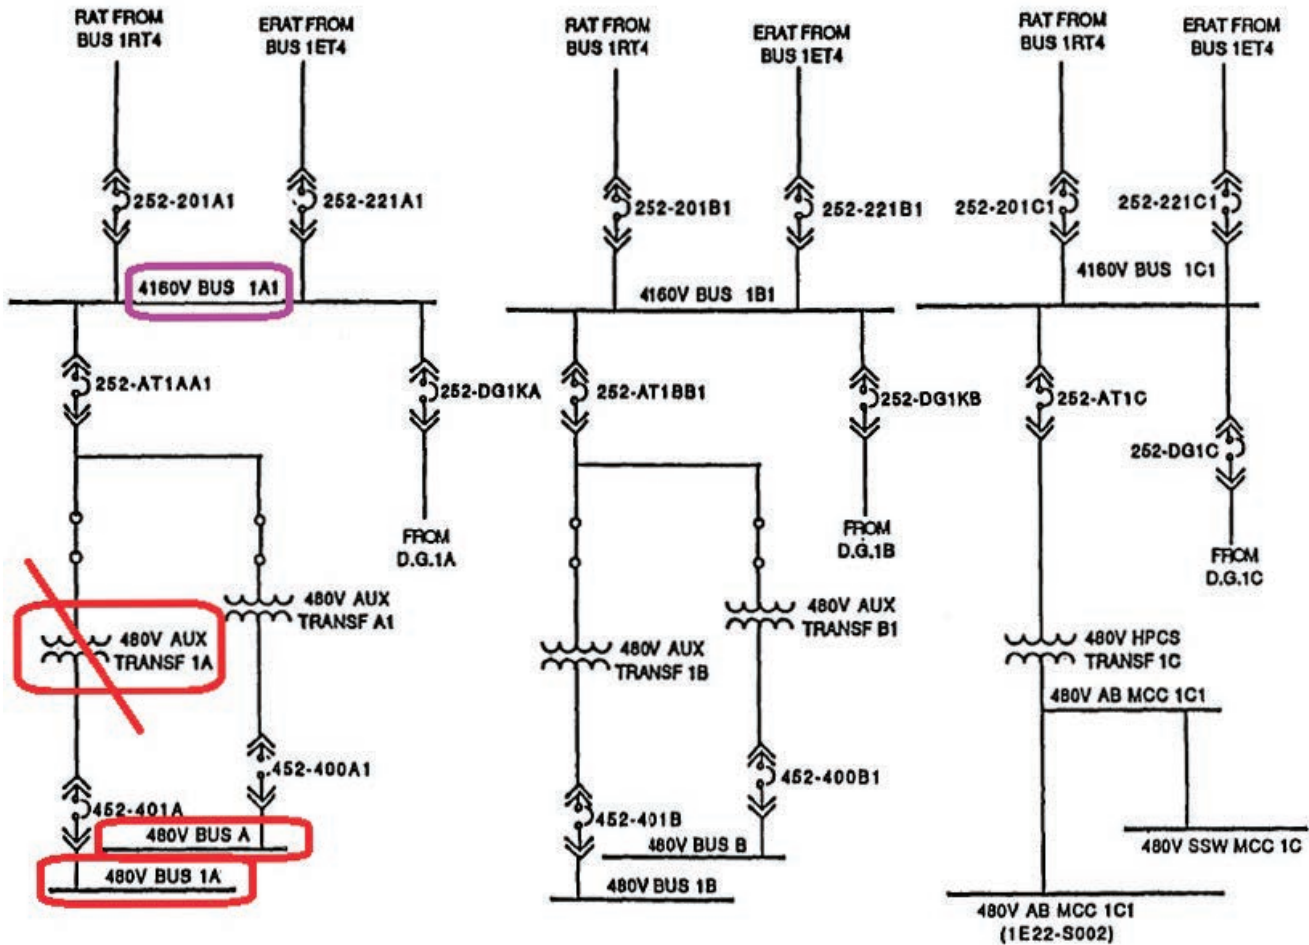
FIGURE 7. 4,160- and 480-Volt Electrical Distribution System at Clinton

The electrical problem that stopped the supply of compressed air to the control rod drive system also stopped the air flow to the main steam isolation valves. Normal leakage would eventually lead to the fail-safe main steam isolation valves automatically closing. Closure of the main steam isolation valves would eliminate the normal method—the main condenser—of cooling steam produced in the reactor vessel, and could thus result in one or more of the safety/

Another electrical problem at Clinton caused more equipment at Clinton to lose power.

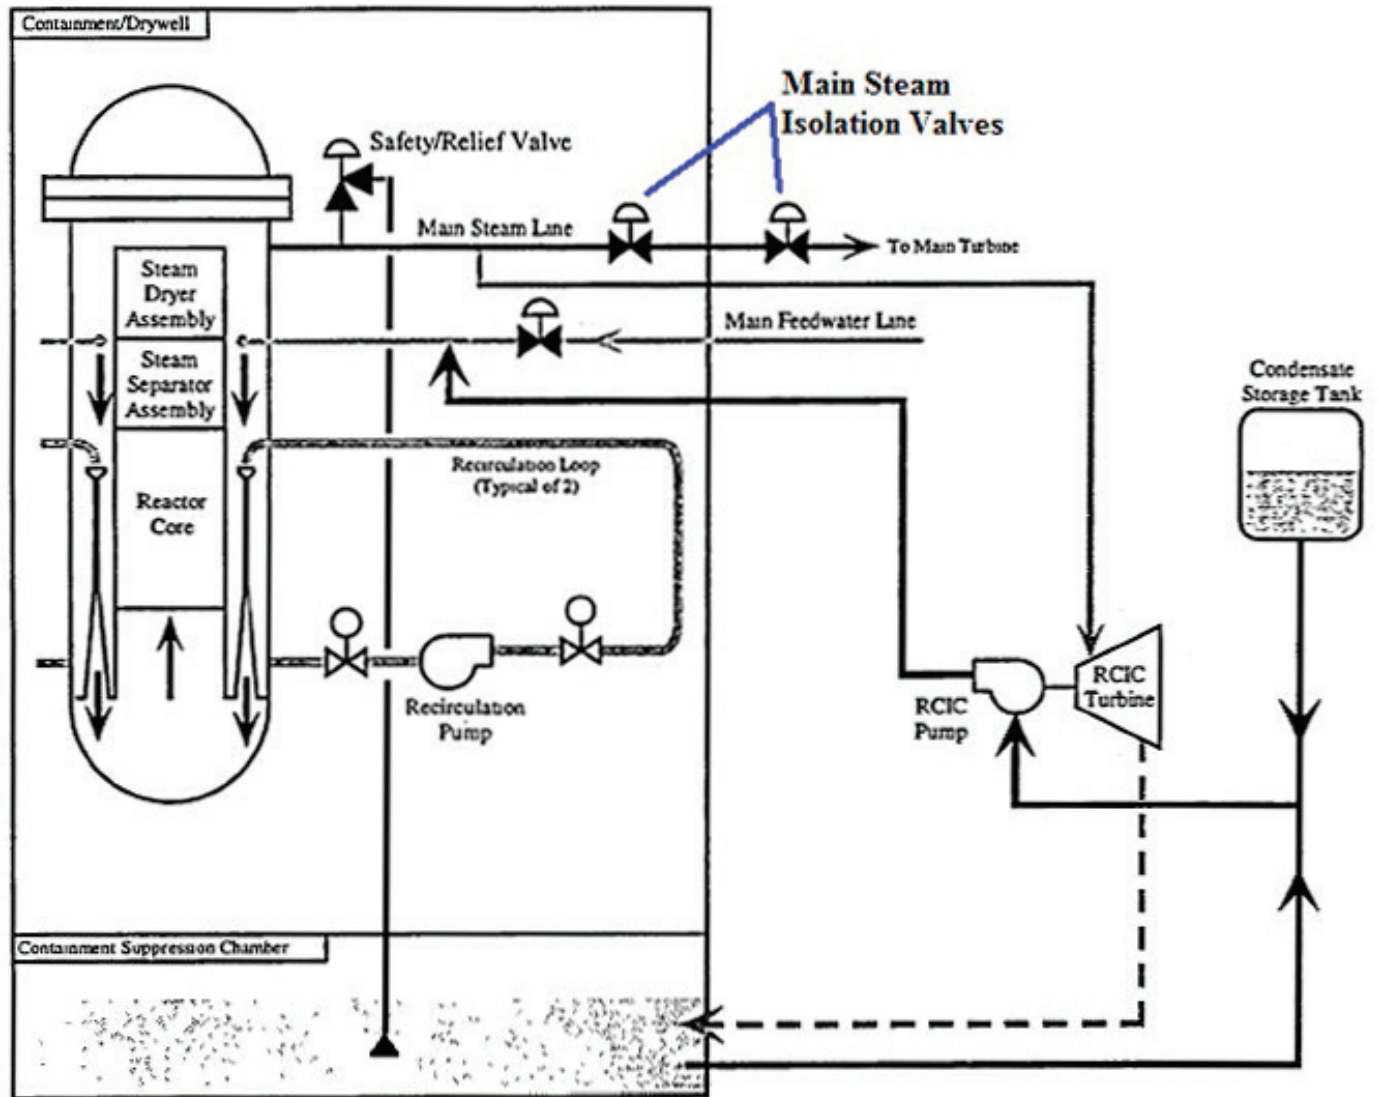
FIGURE 8. Reactor Core Isolation Cooling (RCIC) System

The de-energized equipment at Clinton might cause the main steam isolation valves to close, forcing the pressure inside the reactor vessel to increase. Workers started the Reactor Core Isolation Cooling system that used steam from the reactor vessel. This step offset the closure of the main steam isolation valves and controlled pressure inside the reactor vessel.

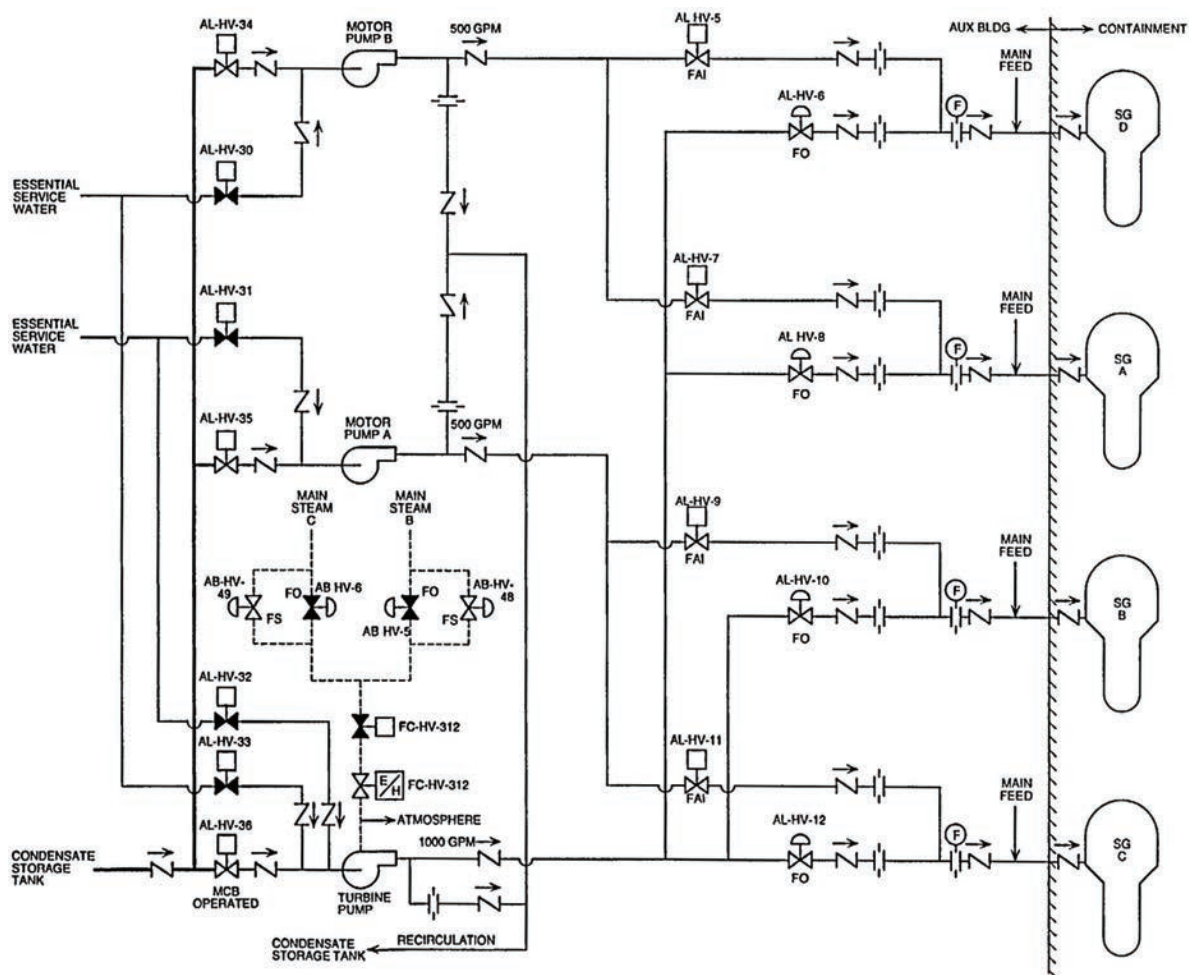
FIGURE 10. Auxiliary Feedwater System on Millstone Unit 3

During a test run on January 23, 2014, the TDAFW pump again automatically shut down due to excessive turbine speed as it was starting. This time, workers did not blame water condensing in the steam supply lines. Conducting a fuller investigation, workers found that part of the control linkage between the turbine speed governor and the control valve had been installed backwards. They also found that a wrong part had been installed in the control linkage. The wrong part lacked an aluminum bronze insert that allowed the metal parts to move freely. These parts had been improperly installed during the original maintenance in May

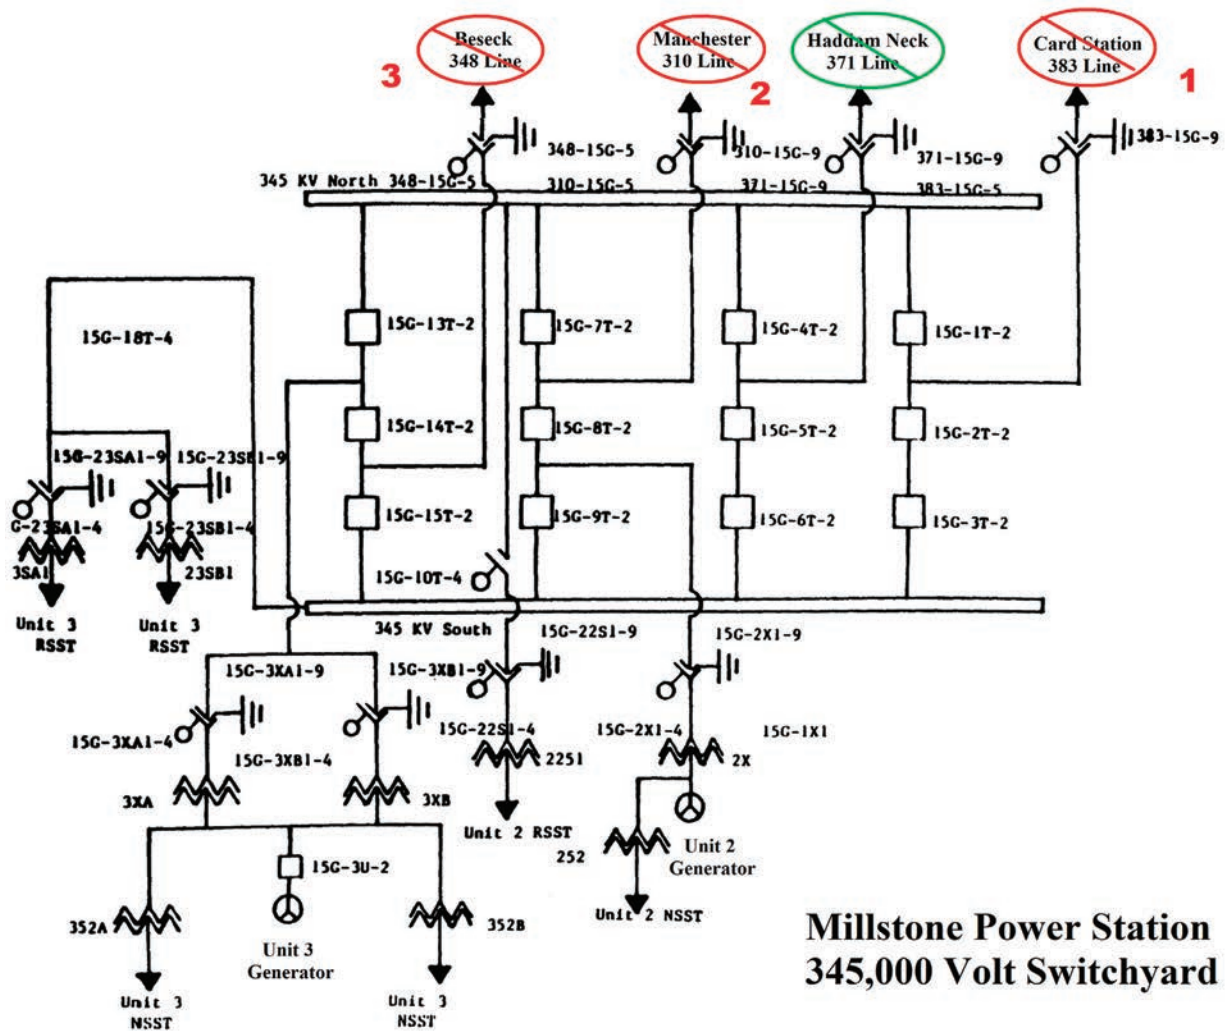
FIGURE 11. Electrical Distribution System at Millstone

The electricity generated by the two reactors at Millstone is carried to residential and commercial customers via four transmission lines. Prior to this event, one transmission line had been removed from service for maintenance. An electrical problem at an offsite substation tripped another line and started a domino effect that caused all four lines to be lost.
